14<sup>TH</sup> CANADIAN MASONRY SYMPOSIUM  
MONTREAL, CANADA  
MAY 16<sup>TH</sup> – MAY 19<sup>TH</sup>, 2021

**EXPERIMENTAL INVESTIGATION OF UNREINFORCED MASONRY VENEER WALL  
SYSTEM UNDER OUT-OF-PLANE LOADING**

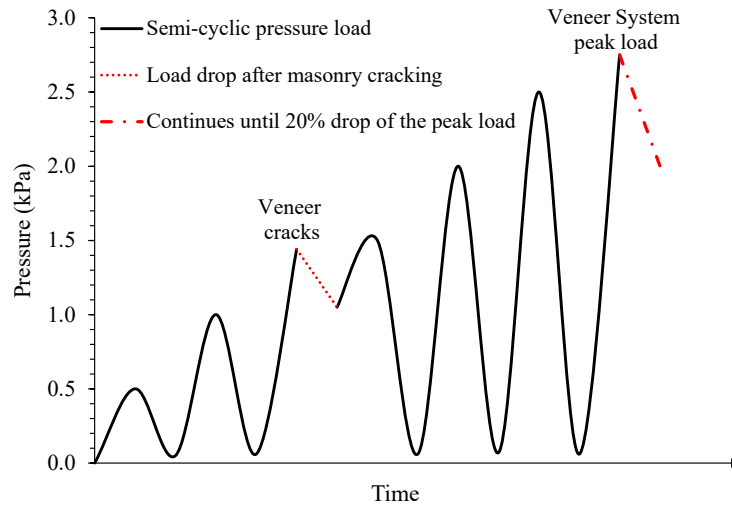
**Figure 4: Semi-Cyclic Pressure Loading History for VWI-10 Specimen**

Uniformly distributed pressure loading was applied slowly via the airbag system. For nine out of ten walls, the pressure was applied monotonically and was continued beyond collapse (peak) load. For the last specimen, the pressure was applied in cycles of loading and unloading as shown in Figure 4. Each test was terminated when the post-peak lateral pressure dropped by at least 20% of the peak load.

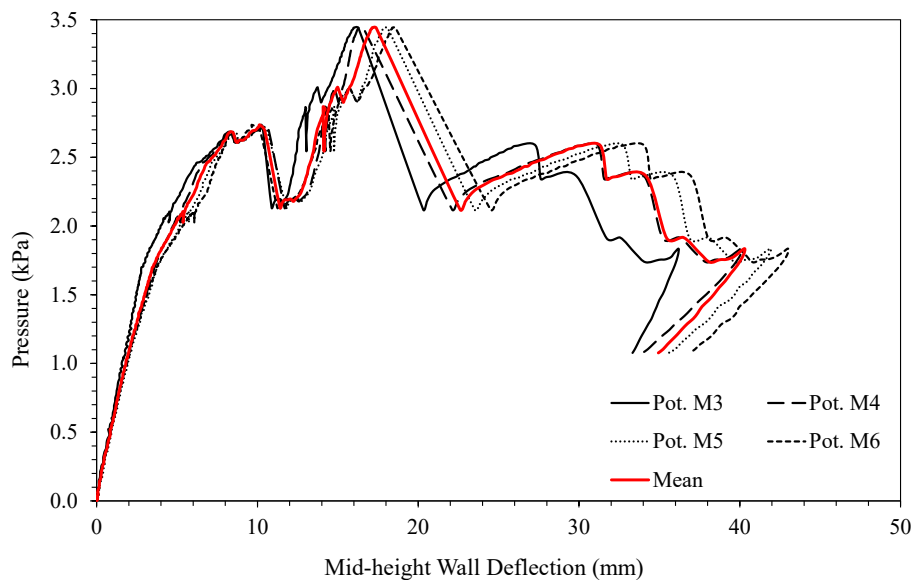
**Figure 5: Pressure vs. Mid-height Wall Deflection of VW-1 Wall Specimen**

During each test, the following observations were recorded: applied pressure, including the wall's load-carrying capacity (wall collapse load), out-of-plane displacements of the masonry veneer, individual tie deformations, and bending deflections of the timber framing studs. The typical trend of the pressure versus wall mid-height displacement curve was, veneer cracking at a mean load of 1.84 kPa, followed by a sudden small pressure drop, then increasing pressure until veneer system peak load was achieved, where randomly different rows of the wall ties buckled or nails pulled out (in the direction of force) from the timber studs. Examples of this response can be seen in Figures 5 to 7. Table 1 summarises the key results (masonry cracking and veneer system peak load and associated displacements) for all wall specimens with mean and COV values.

Compared to all other specimens, VW-1 exhibited considerably higher masonry cracking ( $P_{cr}$ ) and system peak load ( $P_{max}$ ). This is believed to be the result of VW-1 having stronger masonry (higher flexural bond strength) as a result of the increased curing time leading up to this first test. The higher cracking resistance for VW-1 resulted in buckling of some of the ties before masonry cracking, unlike the remaining specimens, for which veneer cracking occurred prior to any significant non-linear behaviour in the ties. Figures 5 to 7 show the load versus veneer mid-height displacement behaviour for three of the walls, VW-1: higher cracking load than any specimens, VW-2: representative of the remaining eight monotonically tested specimens and VW-10: subjected to semi-cyclic loading. From the mean-envelope curve of Figure 6, it can be said that the monotonic response envelopes the cyclic response quite closely. However, due to the cyclic nature of the loading, the system's displacement capacity increased significantly (38.78 mm). The COV for overall veneer system peak load was considerably less (0.12) than the COV of masonry cracking load (0.21), which indicates the higher variability in masonry strength properties compared to other materials (ties) in the wall system.

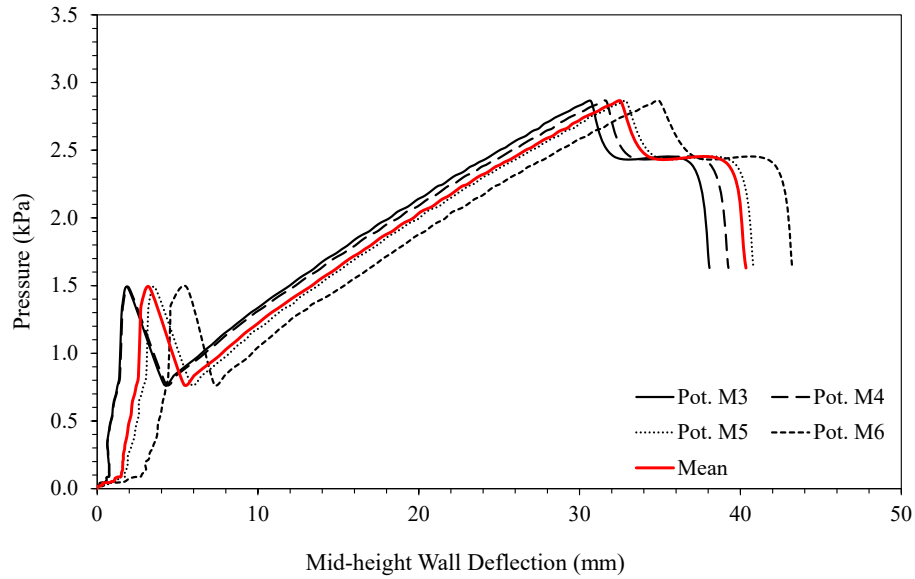
**Figure 6: Pressure vs. Mid-height Wall Deflection of VW-2 Wall Specimen**

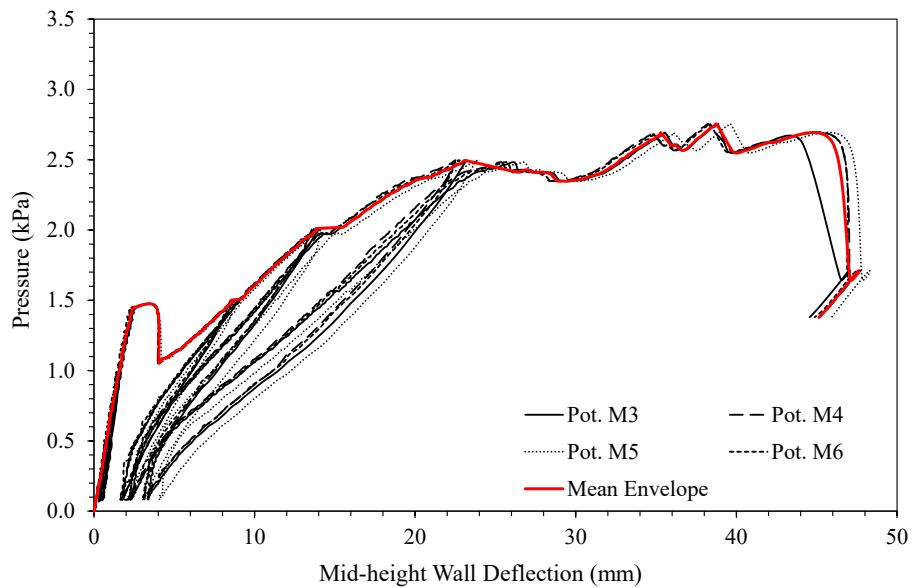
**Figure 7: Pressure vs. Mid-height Wall Deflection of VW-10 Wall Specimen**

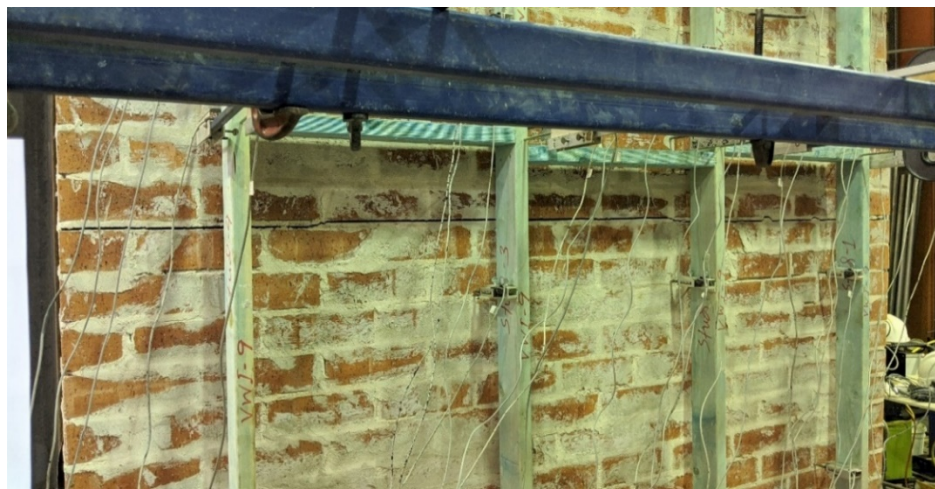
**Figure 8: Brick Veneer Cracking Under Out-of-plane Loading**

Eight out of ten walls exhibited a single horizontal layer of the crack through the brick-mortar interface. The lowest crack level was observed at courses between 11 and 12 (from bottom) and the highest in between 15 and 16 (see Table 1). The position of cracking depends upon the maximum flexural tensile stress induced by the applied out-of-plane pressure loading and the presence of a weak joint in the masonry. Therefore, spatial variability in masonry joint strengths plays a significant role in defining the location of veneer cracking. Figure 8 shows the typical

horizontal crack across the wall length observed in the test. The deflected shape of the wall following the development of the veneer crack is shown in Figure 9.

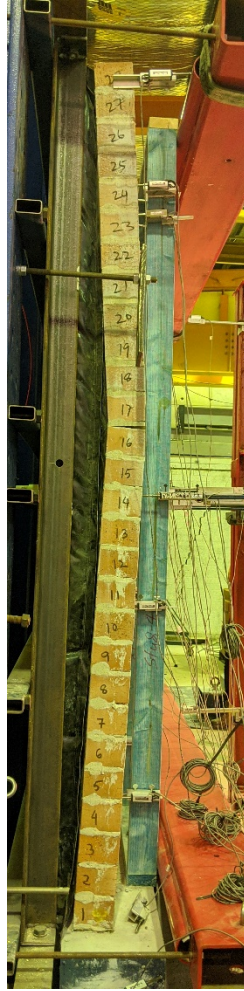
**Figure 9: Deflected Shape of the Wall After Veneer Cracking**

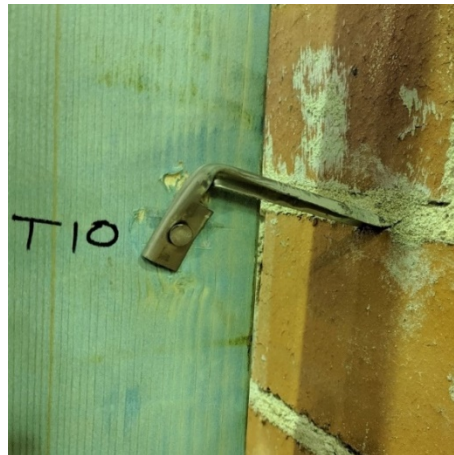
**Figure 11: Typical (Buckling) Tie Failure Observed in Veneer Wall Tests**

The most common tie failure mode observed in the wall testing was the buckling of the tie at 90° across the cavity (see Figure 11), although a few of the ties failed via nail pull out from the timber. It is worth mentioning that a larger number of ties failed via nail pull out for semi-cyclic loading, compared to the monotonic loading. For nail-pull out failure, ties were failed at the tie-nail-timber connection (in the direction of applied pressure) instead of tie bending at the middle, as shown in Figure 12. On the other hand, no timber studs failed during wall tests, which can be interpreted as linear elastic behaviour of the stud.

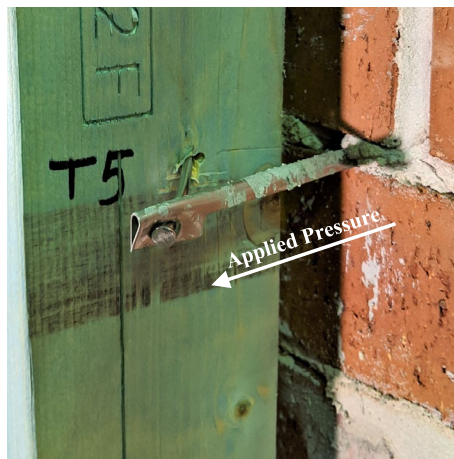
**Figure 12: Nail Pull Out Tie Failure Observed in Veneer Wall Tests**

similar in terms of veneer failure progression, tie yielding and failure, and timber studs deflection except for the first wall (VWI-1). When flexural tensile strength of the mortar is comparatively higher (VW-1), the top two rows of ties failed before masonry cracking; otherwise tie buckling occurred after the veneer cracks somewhere near mid-height. The load-deflection response of monotonic testing enveloped closely the semi-cyclic testing behaviour, which validates the efficacy of the monotonic loading test to identify the system peak load. Tie failure and tie deflection histories are observed throughout the test program and reported in this paper. The typical tie failure was buckling of the tie at a right angle; nonetheless, a substantial number of ties failed by nail pulling out of the timber for the semi-cyclic scenario.
